The 1940 Vrancea Earthquake. Issues, Insights and Lessons Learnt

Proceedings of the Symposium
Commemorating 75 Years from
November 10, 1940 Vrancea Earthquake

Overview of Part I

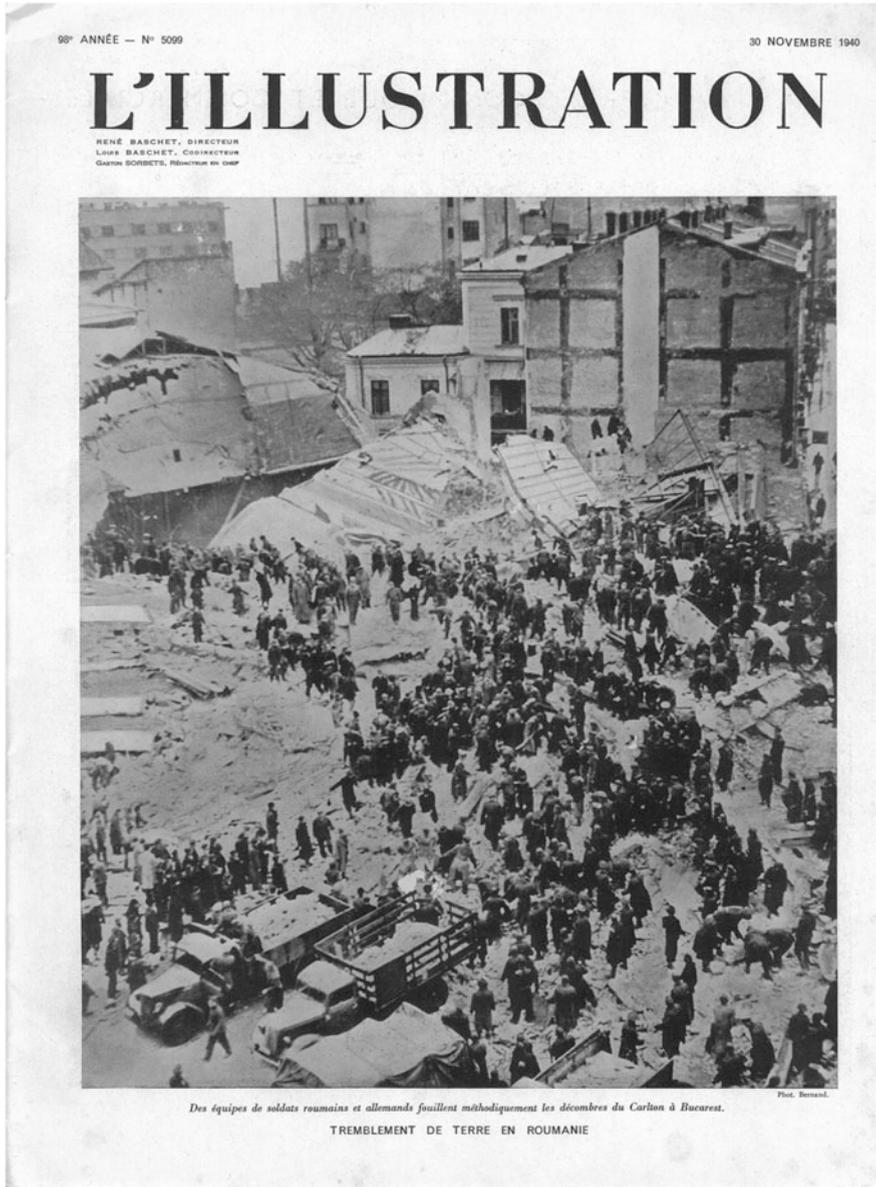
In all reports, a special attention was paid to the collapse of Carlton building in central Bucharest, a modern tall reinforced concrete frame structure that buried in its ruins over a hundred persons, Fig. 1.

Fig. 1 Collapse of Carlton building in Bucharest—Romania during the November 10th, 1940 Vrancea earthquake (L'illustration 1940)

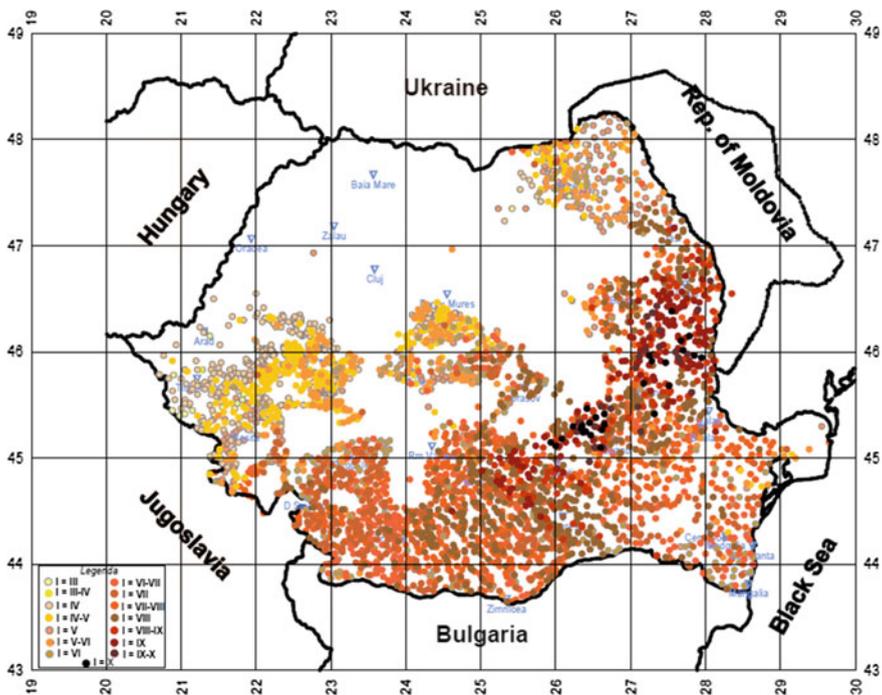
Fig. 3 Reevaluated macroseismic map of November 10, 1940 earthquake (Pantea and Constantin 2011)

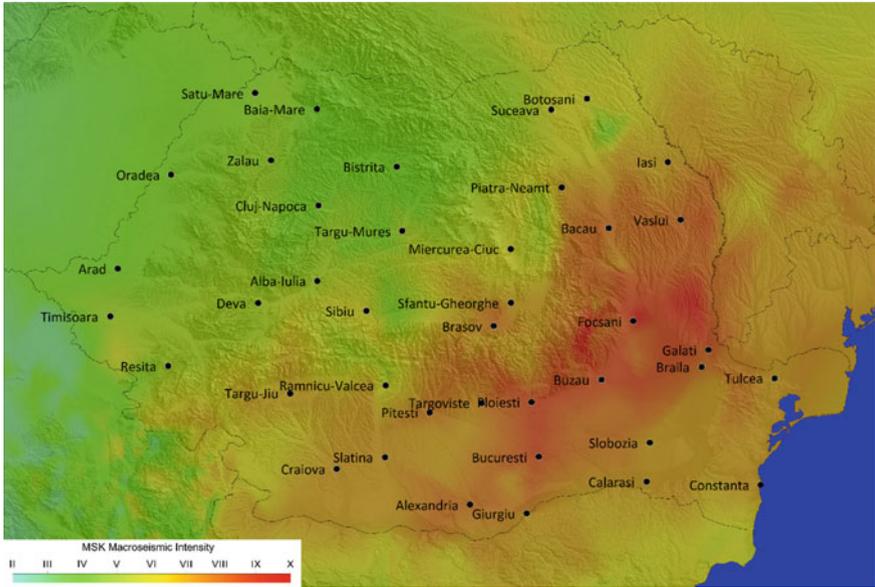
Fig. 4 Macroseismic map of November 10, 1940 earthquake (macroseismic intensities data from Konrod et al. 2013)

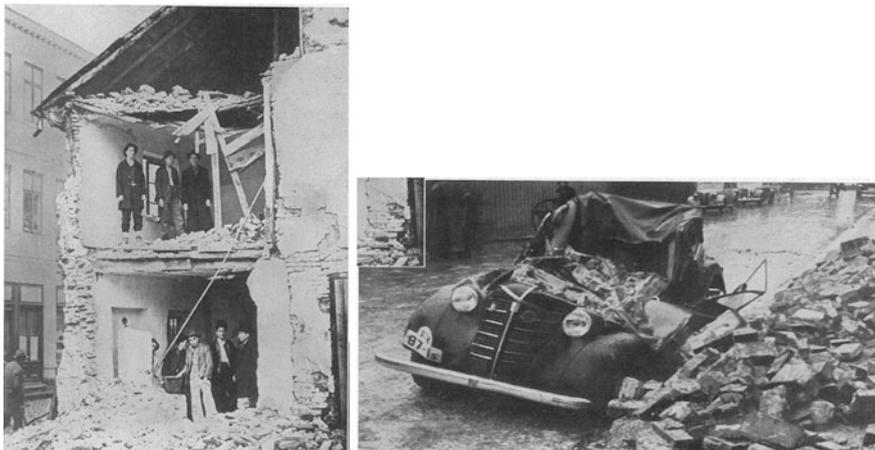
Fig. 5 1940 earthquake damage in Romania (L'Illustration 1940)

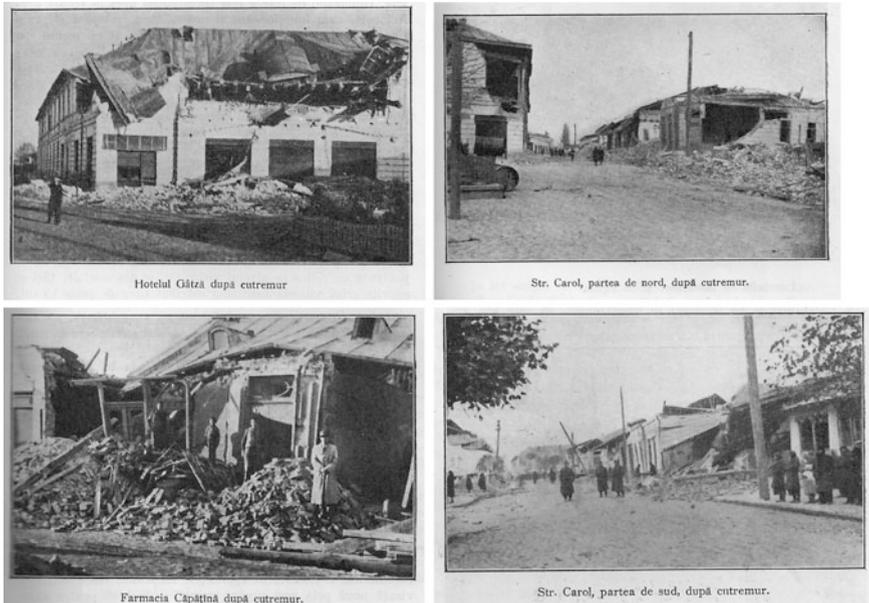
Fig. 6 1940 earthquake damage in Panciu, Romania (Capatana, 1941): Hotel Gatza (*upper left*), Capatana Pharmacy (*upper right*) Carol Street (northern part *lower left* and southern part *lower right*)

A special damage case was the city of Panciu. All news, national and international attracted the public attention toward the city of Panciu, located in the epicentral area, and national and international aid was directed to support Panciu inhabitants. Images and TV news showed King Michael of Romania visiting the city soon after the earthquake. Capatana (1941), the mayor of the city at that time, presented an overwhelming picture of the disaster: "the only town in Romania that was 99 % destroyed, from 371 masonry houses only 5 stood up, together with 57 adobe or wooden houses at city borders." Capatana also mentions about 42 dead persons and 76 injured from which several died later. The almost entire ruin of the city, Fig. 6, induced a special reaction from Romanian state who issued a Law (1942) for the city reconstruction.
