MAINTAINING AND REPAIRING

Old and Historic Buildings

John J. Cullinane, AIA

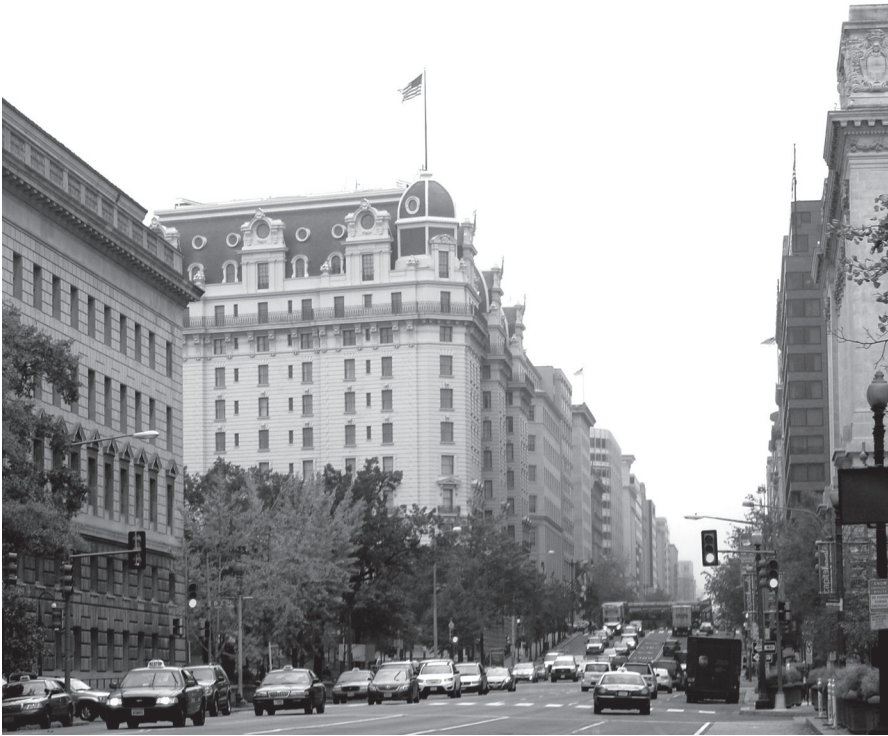
FIGURE 1.1 Willard Hotel,
Washington, DC

The Willard Hotel (Figure 1.1) was threatened with demolition for decades before being rescued with the aid of a special appropriation by Congress to stabilize the structure. A local developer then undertook a project to rehabilitate the building and return it to its former status as the premiere hotel in Washington, DC. Additions to the hotel were placed on an adjacent site to increase the number of rooms and to provide commercial space. The project was undertaken using the Secretary of the Interior's Standards for Rehabilitation, and received federal tax credits for the work done.

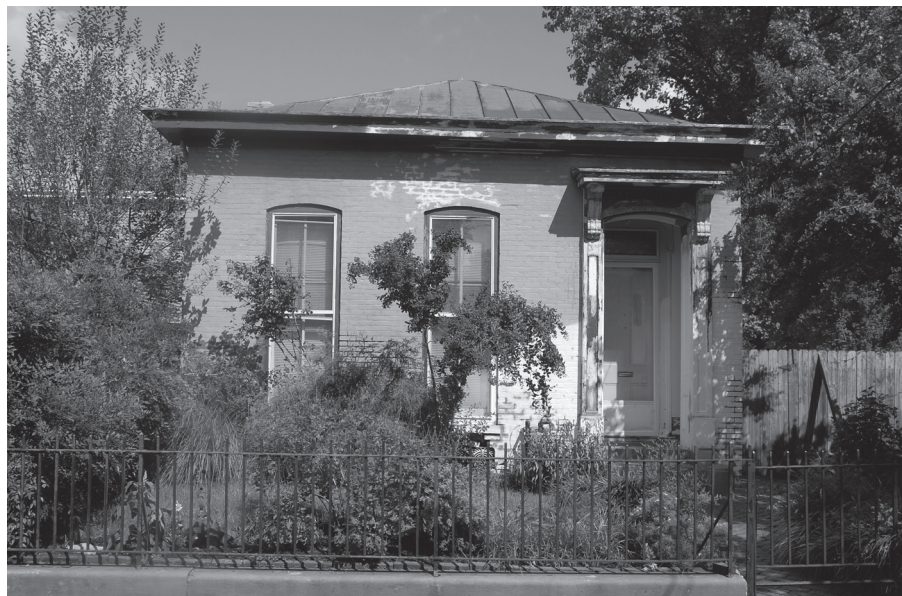
FIGURE 1.2 Shotgun House, Butchertown, Louisville, Kentucky

Butchertown neighborhood of Louisville, Kentucky (Figure 1.2). This style of building was common to towns along the Mississippi and Ohio Rivers, and elsewhere in the Northeast. Individually they are interesting pieces of architecture and history, a blend of simple Federal style with Victorian details. In the context of a neighborhood, they foretell the development of company towns, such as Pullman, outside of Chicago. They were workers' housing built within a larger city, which now form historic districts in many communities.

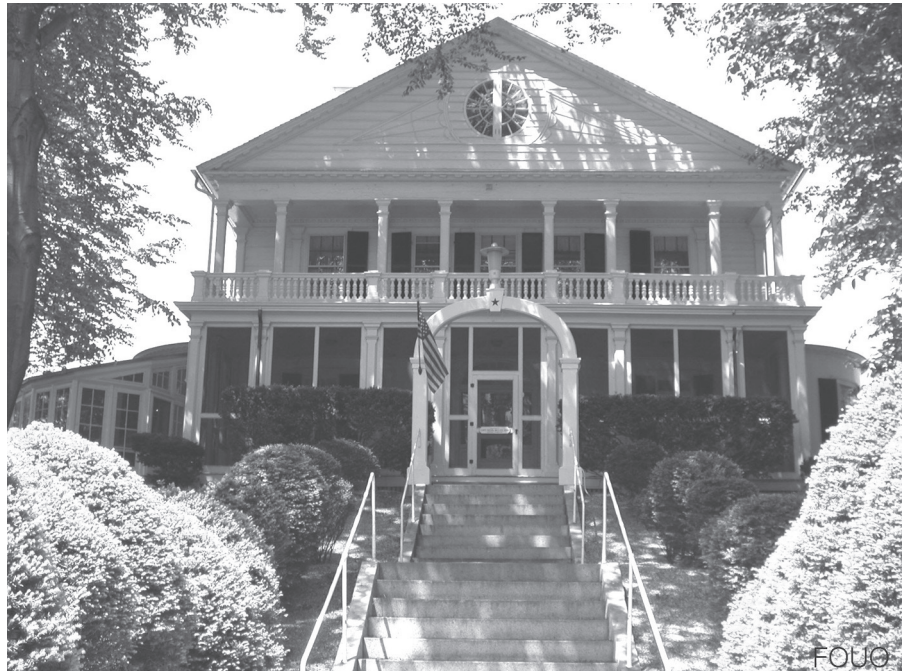
FIGURE 1.3 Commander's House Portsmouth Naval Ship Yard, Kittery, Maine

The front elevation of the Commander's Residence, at the Portsmouth Naval Shipyard in Kittery, Maine (Figure 1.3) illustrates the dramatic style of the building. Dating from the mid-19th century, this building has been rehabilitated and continues to serve its original purpose more than 150 years later. The interior of the building illustrates craftsmanship in wood detailing and in the stairway design. Residences for senior officers constructed at military installations mimicked high-style houses in the private market, complete with steward's quarters and commercial-scale kitchens. Historic family housing continues to be the most favored type at military installations because of the buildings' design, style, and size.

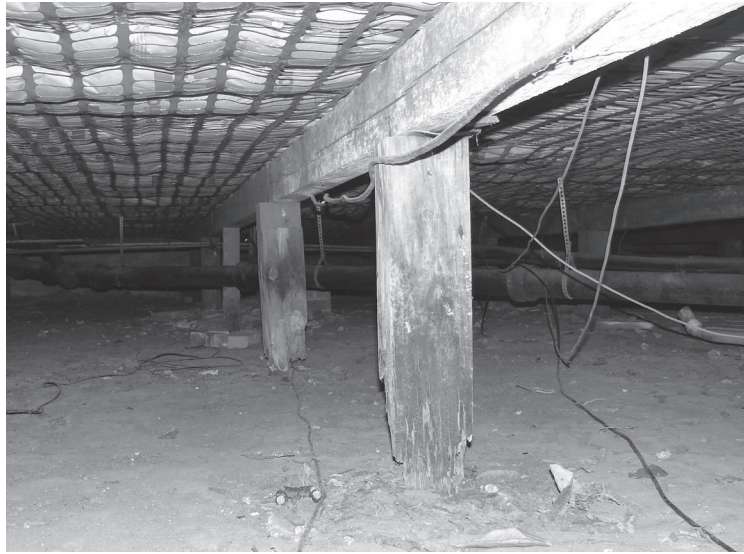
FIGURE 1.4 Deteriorated wood piers

Figure 1.4 is a photograph of a wood pier that has been eroded by wind and weather. Hidden under a crawl space, the deterioration continued completely unnoticed. Often, a structural failure is the first indication of a problem.

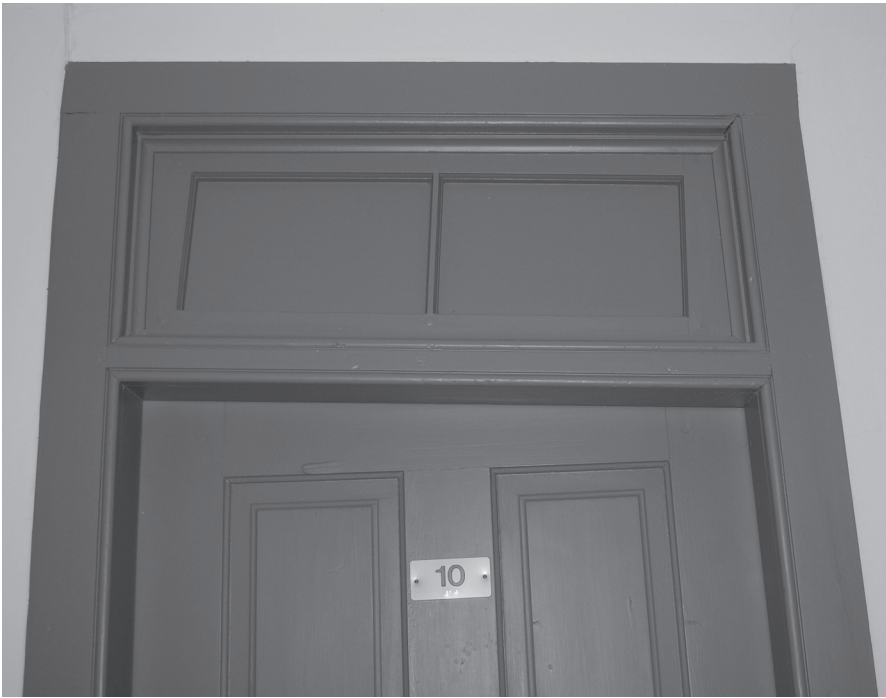
FIGURE 1.5 Wood door, Robert Morris Inn, Oxford, Maryland

Figure 1.5 illustrates attempts at a workaround for structural failures rather than finding the cause of the problem. Something settled in the foundation or floor or ceiling. The end result is that shifts in the structure made it impossible to operate this door. The door was “trimmed” so that it would continue to function. Likely the first “trimming” was modest, but as the structure continued to move, the door changed shape to accommodate the frame. This is an obvious indication that further investigations of the stability of the structure have to be undertaken, failures identified, and corrections made, and then the door and frame can be repaired or replaced.

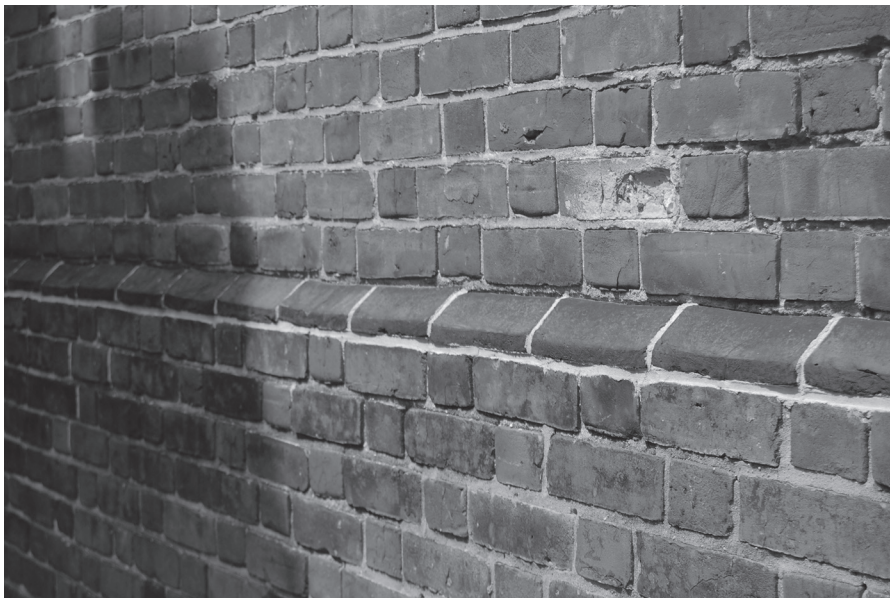
FIGURE 1.7 Brick water table

In old brick and soft stone buildings, an effective method of preventing rising damp was to construct the foundation wall of a very dense stone or brick, which would block passage of the moisture. In an old building it is referred to as a “water table,” shown in Figure 1.7. In 19th century buildings, the water table often protruded and was visible. At the beginning of the 20th century, the water table was often a simple piece of slate inserted in a mortar joint just above the ground. As our technology and skills advanced, new construction started directing the groundwater away from the building with foundation drains, and flashing at the junction of the foundation wall and upper wall will prevent rising damp. Again, knowing how a building is put together can help in developing a plan for doing work.

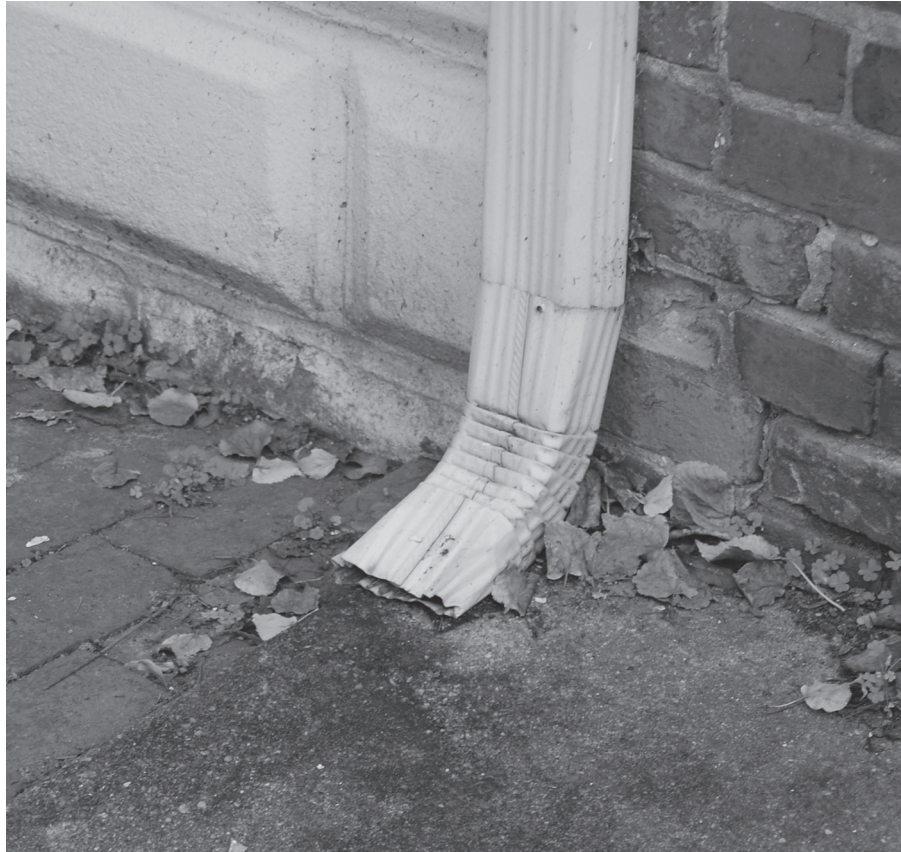
FIGURE 1.8 Crushed
downspout

The source of a water back up problem is not always as obvious as in this situation at a historic building in the Annapolis Historic District in Maryland. The crushed downspout (Figure 1.8), and the failure to repair the damage, resulted in water backing up and filling the gutter to overflowing. The water then penetrated the wood framing, causing damage to the fascia boards and soffits. What was a simple repair has turned into a very expensive project of patching and building materials and finishes.
