Materials & Skills for

# HISTORIC BUILDING *Conservation*

Michael Forsyth

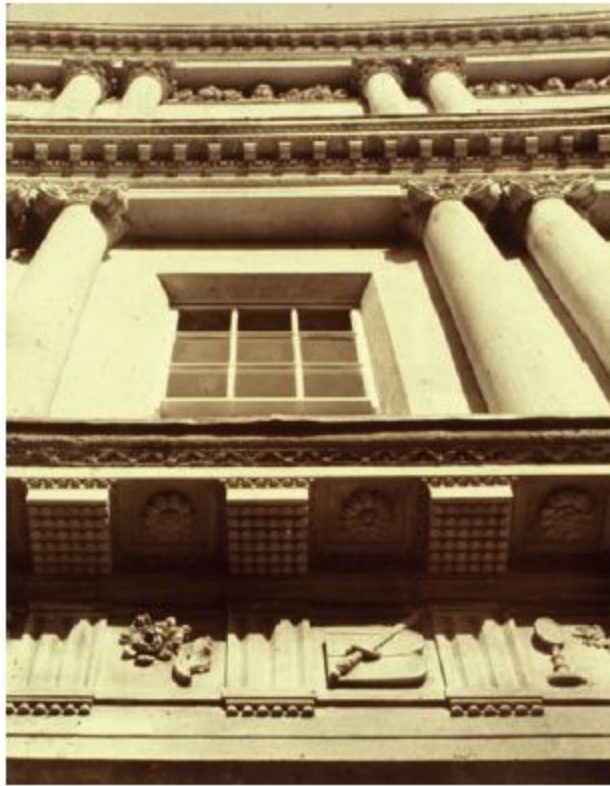
**Figure 2.3** After repairs to 14 Circus during 1973/74.

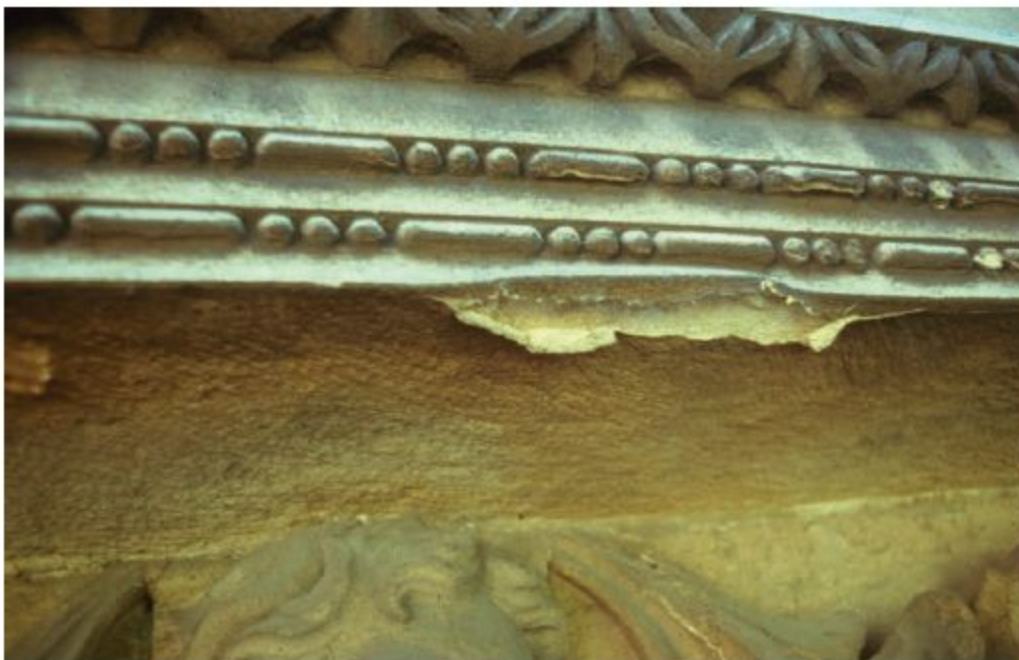
**Figure 2.4** Damage caused by calcium sulphate crystals.

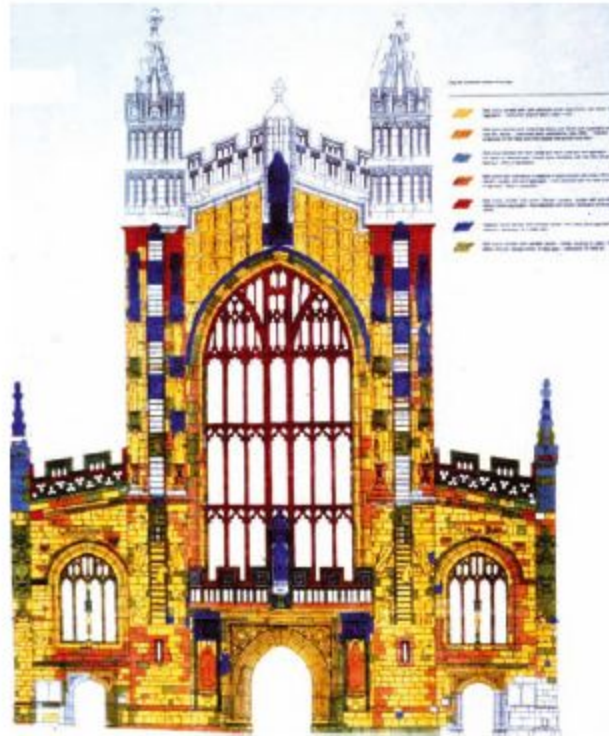
For complex facades it may be helpful to erect an **inspection scaffold** to allow a detailed stone-by-stone, joint-by-joint inspection and analysis to take place. This was done in 1989 on the West Front of Bath Abbey, enabling Nimbus Conservation to make their detailed assessment of the condition of the stonework and for its archaeological recording to be undertaken by Jerry Sampson ([Figure 2.5](#)).

**Figure 2.5** Archaeological recording of the West Front, Bath Abbey.
